Fracture characteristics of high impact polystyrene under impact fatigue loadings

Abstract This study analyses the impact properties of high impact polystyrene (HIPS). HIPS is one of the well-known toughened polymers. The high toughness is given by the rubbery phase. The impact fatigue behavior of HIPS was studied with a Ceast pendulum type tester (Resil 25). The fracture mechanisms were examined with a scanning electron microscopy. The nature of crack initiation and propagation was investigated for small impact angles and three different spans. The impact angles of charpy hammer were chosen as 5°, 10°, 15°, 20°, and 25°. The fracture characteristics varied with the impact angle, the number of impacts, and the distance between supports. The rate of crack propagation was high at higher impact angles with lower endurance, and low at lower impact angles with higher endurance.

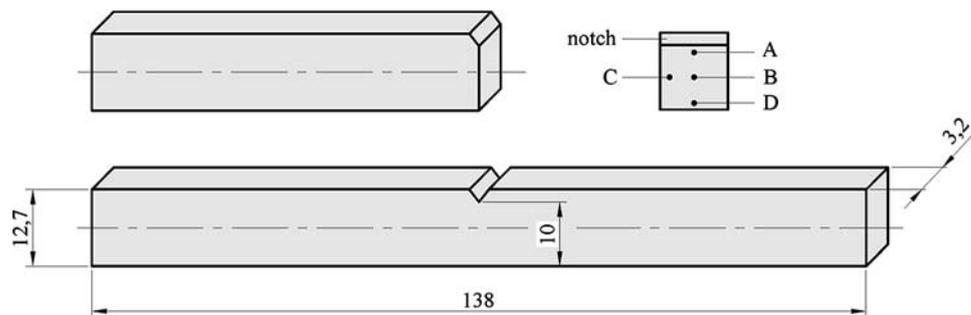
To determine the impact fatigue behavior, the samples were prepared according to ASTM D 256 standard. Notched samples with dimensions of $3.2 \times 12.7 \times 138 \text{ mm}^3$ were illustrated in Fig. 1. As shown in Fig. 1, SEM investigations were focused on A–D regions of the notched cross section of the charpy test samples.

Fig. 1 Geometry and location of A–D regions at the cross section of Charpy impact sample

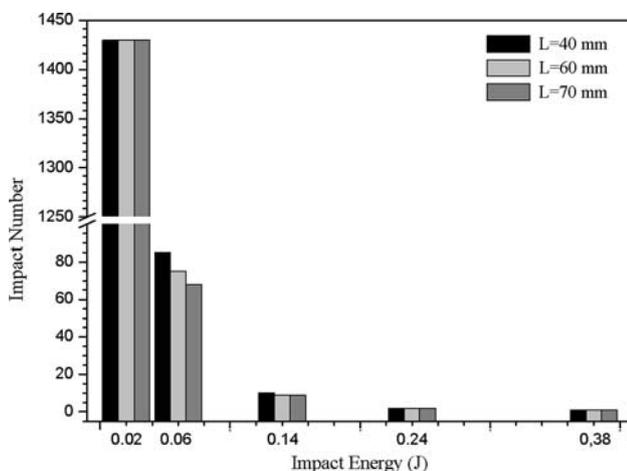
Figure 2 shows the impact fatigue test results performed at different impact energies. Although small variations exist due to the distances between the supports, as expected, the material fractured through small impact numbers in case of dropping the hammer from higher angles while lower drop angles required higher impact numbers. During the tests hammer permitted to hit the sample only one time at given

Fig. 2 Failure number depending on impact energy and the span (L)

impact energy and the second hit was prevented. Samples were fractured after the impact number of approximately 1430 for 0.02 J (for each span values). On the other hand, the samples were fractured after less number of impacts as the distance between the supports (span) increased. Not surprisingly flexural displacement of the material, during the tests, increases as the distance between the supports increases. Therefore, the flexural stresses, and consequently deformations at crack tip also increase. As a result the impact number up to fracture was observed lower, as the distance between supports was longer.

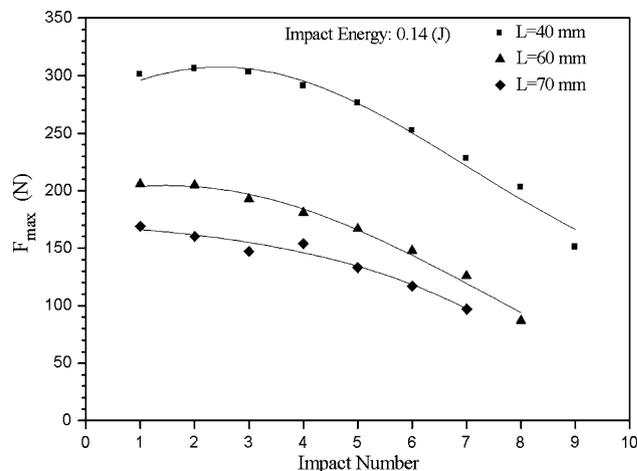
Figure 3 shows the variations of obtained maximum forces during the impact fatigue study as a function of the span values while the impact energy is kept as constant at 0.14 J. In case of lowest span value ($L = 40$ mm), the samples were fractured after nine impacts. The sample behaved like a “more rigid” material compared to original because of the shorter span value, and therefore, higher F_{\max} values are measured at this span compared to $L = 60$ and 70 mm. During the crack propagation in the material, the remaining cross section of the sample is decreased at each impact. Therefore, F_{\max} value obtained from the actual impact was lower than the previous one. Samples tested at wider span values fractured at less number of impact cycles, because of higher bending moment values.

Fig. 3 F_{\max} variations for 0.14 J of impact energy

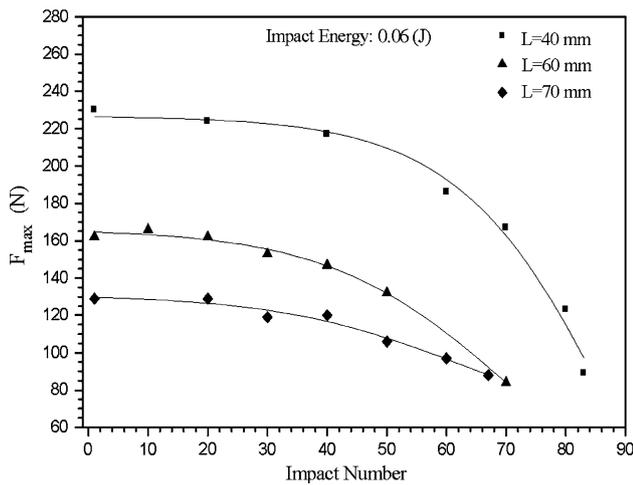
Variations in F_{\max} for impact energy of 0.06 J were shown in Fig. 4. The results are very similar with the variations shown in Fig. 3. In Fig. 4, samples were fractured after higher impact numbers compared to Fig. 3. Also smaller span values give higher F_{\max} values and higher impact number up to fracture. In Fig. 5, not surprisingly F_{\max} values are quite lower compared to Figs. 3 and 4, also as expected the samples were fractured after high impact numbers. This phenomenon has also been observed in SEM examinations of the samples. In the case of higher impact angles, crack propagation lines were observed after each impact.

Fig. 4 F_{max} variations for 0.06 J of impact energy

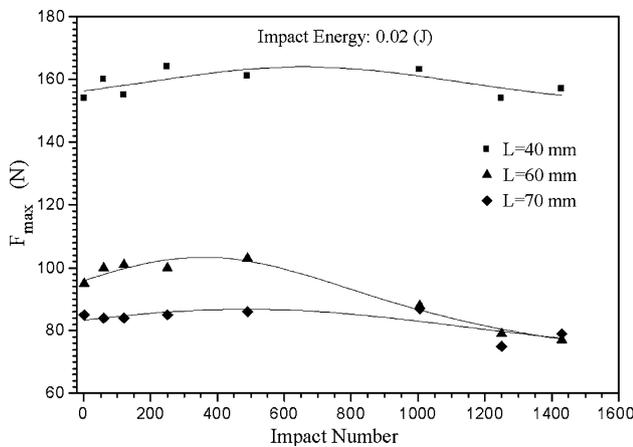
Fig. 5 F_{max} variations for 0.02 J of impact energy

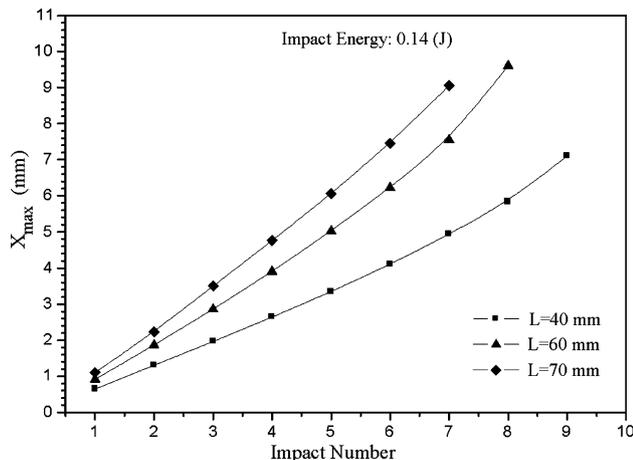
Figure 6 illustrates the variation of deformation rates as a function of impact number of the hammer. It is observed that crack propagation rate increases approximately in linear manner as a function of impacts, and failure occurs after the maximum deformation. As shown in Fig. 6, certain amount of deformation is achieved at smaller energy level impacts and larger number of loading cycles.

Fig. 6 X_{max} variations for 0.14 J of impact energy

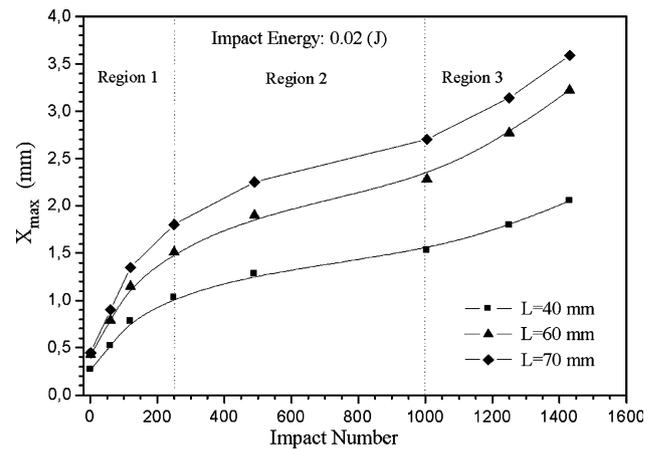
Figure 7 shows deformation rates as a function of impact numbers for impact energy of 0.02 J. At this low-energy value, crack propagates very slowly during each repeated impact. The curves of deformation rate (crack propagation rate) have three different regions similar to crack propagation behavior of the materials during fatigue

loading. In region 1, it is observed that the deformation rate shows proportional increase with impact numbers up to 200–250. There is a high deformation rates observed in

Fig. 7 X_{max} variations for 0.02 J of impact energy

region 1. On the other hand, between the 250 and 1000 impacts there is comparatively lower crack propagation rate. In region 3, the deformation rate increases, crack reaches its critical length and fracture occurs at the end of this region. Crack propagation was very limited during the repeated impacts of 0.02 J. Therefore, crack propagation lines did not occur in the structure. Decrease in F_{max} values of impact energy with 0.02 J was not as obvious as in the other impact energies for each span values. However, the crack propagated and failure occurred after approximately 1,400 impacts. The fact that no variation occurred in force values during crack propagation indicates that plastic zone and stiffening formed on crack tip produced a strong resistance against every next impact.

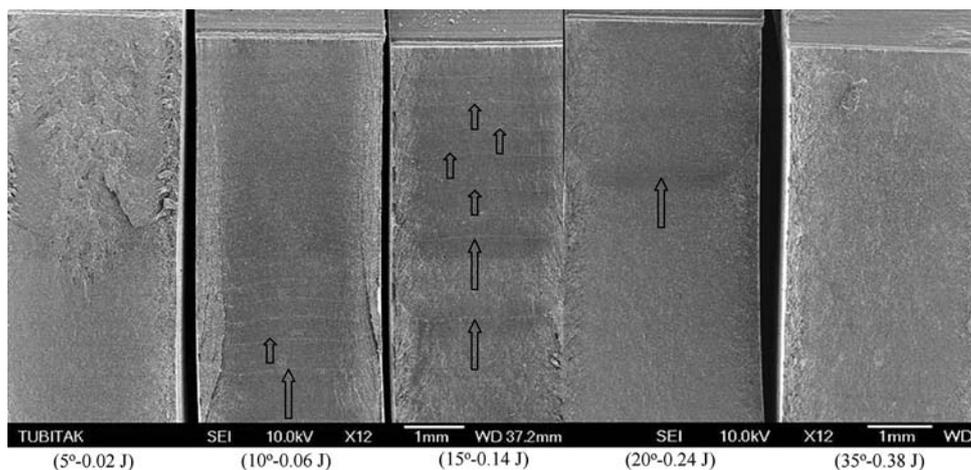
Figure 8 shows SEM micrographs taken from the materials' cross sections, which are fractured after repeated impacts. At the left hand side, image represents the fracture surface of the sample fractured with repeated impacts of 0.02 J. Considering the cross section of the fractured material, it is seen that higher plastic deformation traces exist on the cross sections compared with other fractured samples with higher hammer energies. The cross section does not seem like there was planar crack propagation. Crack propagation line formation was not observed. Crack propagation lines are clearly visible on the sample's cross section of the fractured sample after repeated impacts of 0.06 J. The notch, which was produced by machining, is seen on the upper sides of the images. Crack propagation direction is from top toward down of the sample. It was observed that crack propagation lines at notch tip are closer to each other and the distance between them became longer after each impact. It was also observed that the distance between these lines, which occurred before final failure, became fairly longer. Higher repeated impact energies give longer distance between the crack propagation lines. This phenomenon can be clearly observed in Fig. 8. In addition, amount of crack propagation increases toward the edge of

Fig. 8 Fracture surface of the sample under different repeated impact energies (span = 60 mm)

the samples. The specimen was fractured after two repeated hammer impacts with impact energy of 0.24 J. According to the surface examinations after failure, the only one crack propagation line occurred on the cross section is seen clearly. The cross section of the sample fractured with single impact, and impact energy of 0.38 J is shown in Fig. 8. No crack propagation line exists on the cross section because the sample was fractured with single impact.

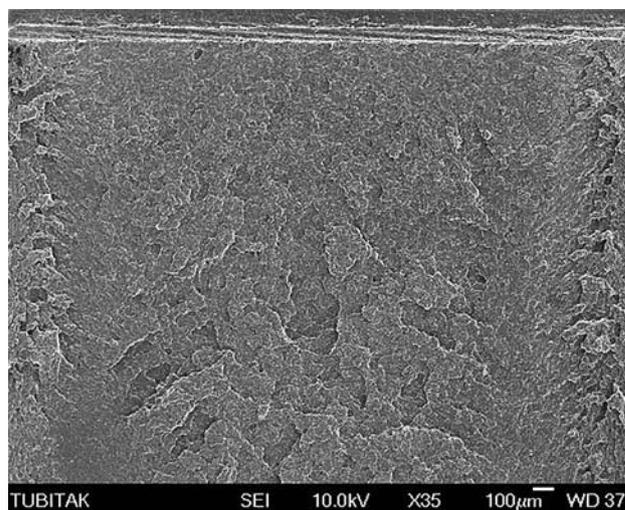
Figure 9 illustrates the “region A” of the fractured sample with repeated impacts of 0.02 J. As mentioned above, crack propagation lines were not observed on the cross section of the fracture surface. In the figure, typical ductile fracture morphology is clearly shown. There is high plastic deformation in the cross-sectioned region of the sample.

Fig. 9 Region A in case of $L = 60$ mm and 0.02 J

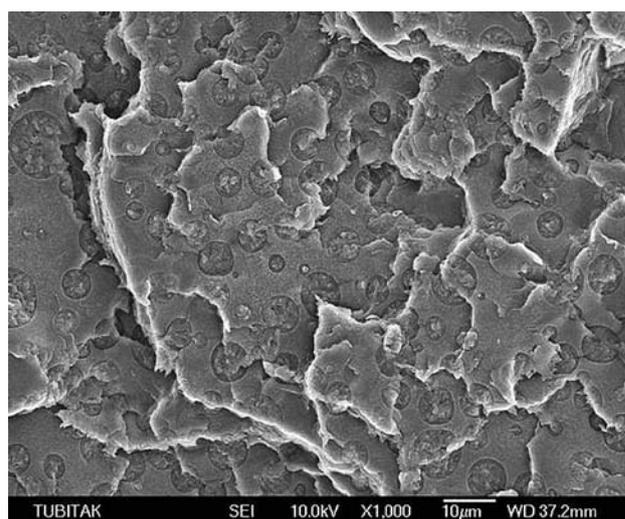
Figure 10 illustrates the same fractured region under high magnification. It is observed from the image that the crack propagated through the particles. The diameter of the particles varies between 2 and 10 μm , and their distribution is clearly seen at the cross section of the fracture surface.

Fig. 10 Region A in case of $L = 60$ mm and 0.02 J (at high magnification)

However, impact energy of the hammer is three times higher in Fig. 13 compared with Fig. 10. Although the spherical butadiene particles are seen on the fractured cross section of the sample in Fig. 10, but these particles are not seen on the fractured surface in Fig. 13. The fractured surface in Fig. 13 is rougher than the surface in Fig. 10. Since cracks propagate inside the matrix material, or matrix–particle interface, or around the particles without passing through the particles, energy absorption during crack propagation is reduced. As a result, brittle type of fracture with lower energy absorption is generated.

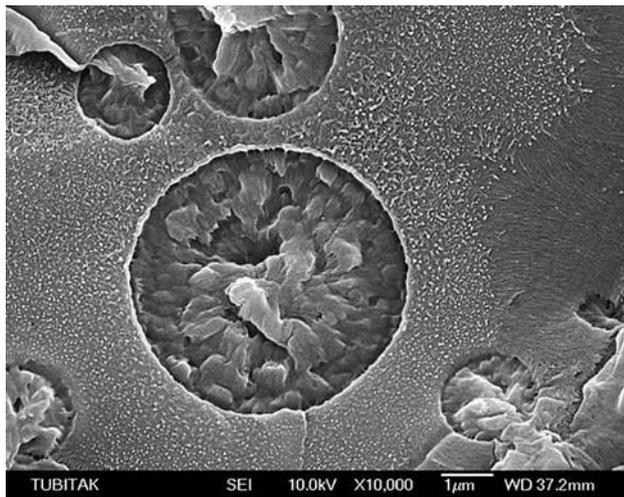
Figure 11 represents the 10,000 \times magnification of “region A.” Note that the crack propagates with smallest impact energy of 0.02 J. The spherical elastomeric particles are not debonded and there are not any observed deformations.

Fig. 11 Region A in case of $L = 60$ mm and 0.02 J (magnification is 10,000 \times)

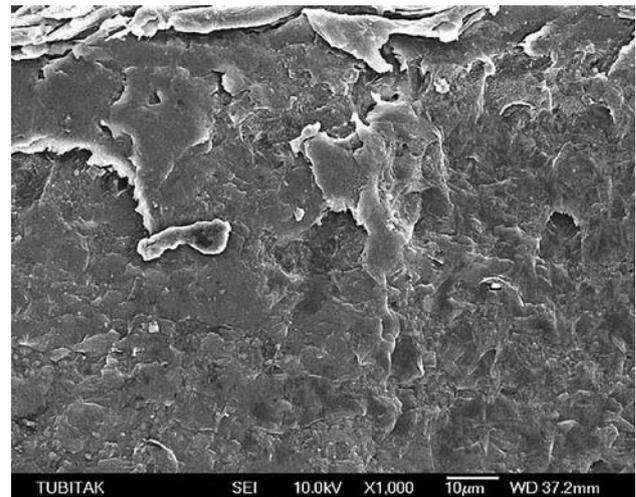
Figure 13 illustrates the “region A” of the cross section of fractured sample with repeated impacts of 0.06 J. Magnification ratios on Figs. 10 and 13 are the same.

Fig. 13 Region A in case of $L = 60$ mm and 0.06 J

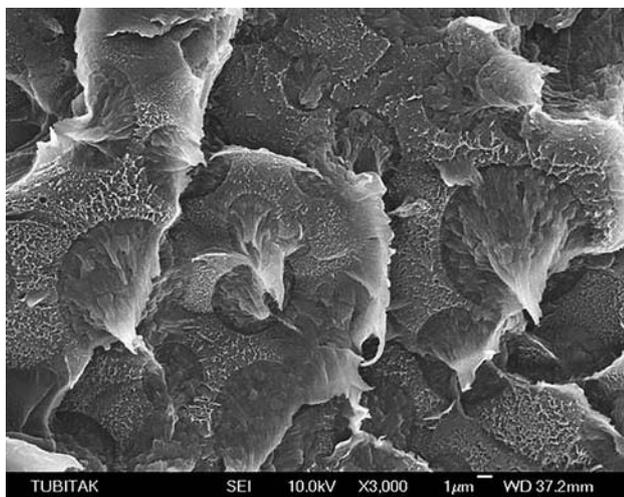
In Fig. 12, “region B” represents the middle of fractured cross section of the sample. As implied above, the crack propagation rate is faster at “region B” compared to “region A.” The higher crack propagation velocity results in deformations in the spherical particles, and higher matrix deformations are observed compared to “region A.” White-colored texture implies that there is large amount of deformation in the elastomeric particles and the matrix material.

Fig. 12 Region B in case of $L = 60$ mm and 0.02 J

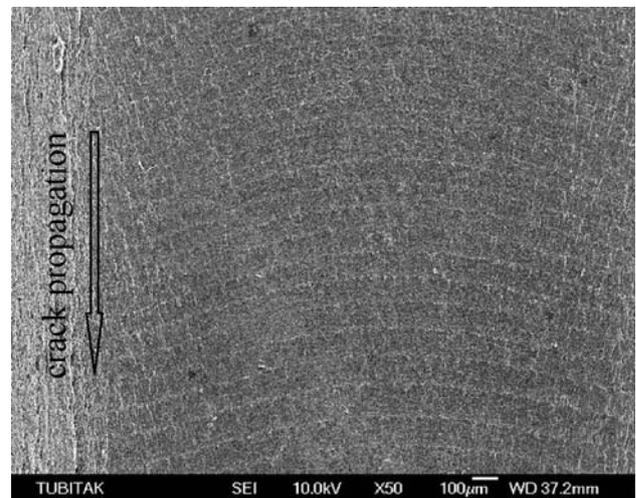
Fig. 14 Region B in case of $L = 60$ mm and 0.06 J

Figure 14 illustrates the “region A” of the cross section of the sample fractured after repeated impacts of 0.06 J. It is seen that the distance between crack propagation lines is extending at each impact. It has been observed that crack propagation distance increases toward the edge of the test sample.

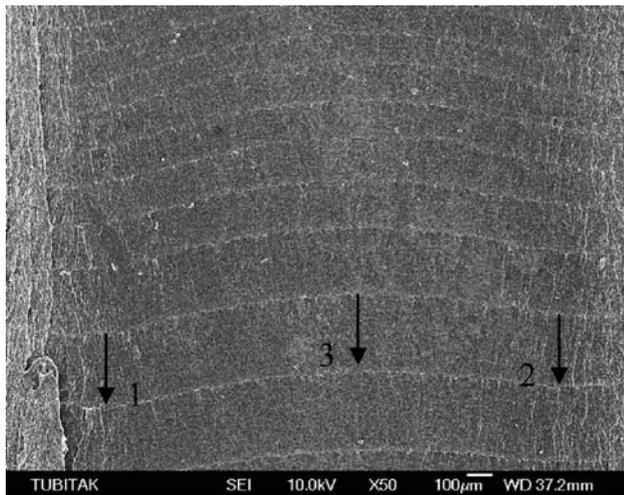
Figure 15 illustrates the SEM image taken from between B and D regions. This micrograph also shows that the distance between crack propagation lines extending from small ranges to gradually longer ones. The distance between these lines is approximately 100 μm on upper sides of the region while it reaches up to 300 μm toward to lower sides of the region. The cracks are in the form of rough arches on the upper sides of the region. On the other hand, it is seen that the crack tips propagate faster at the left and right edges (arrows 1 and 2) of the sample compared with the center of the sample (arrow 3).

Fig. 15 Regions B–D in case of $L = 60$ mm and 0.06 J

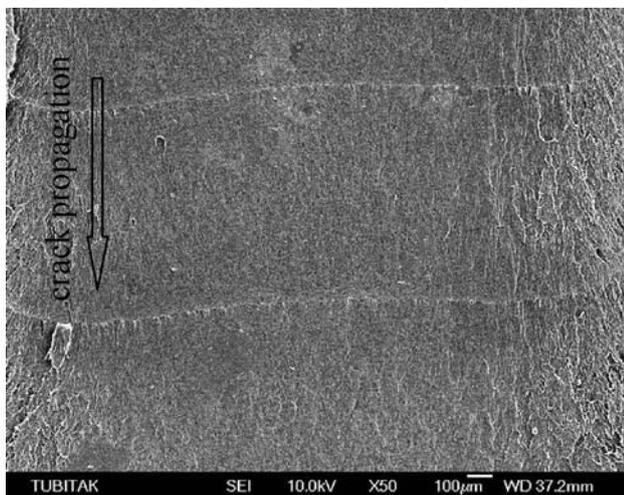
Figure 16 illustrates the last two crack propagation lines in “region D” of the fractured sample. The distance between the last two crack propagation lines is approximately 1000 μm . Crack propagation velocity is still lower at central region of the failure surface compared to edges.

Fig. 16 Region D in case of $L = 60$ mm and 0.06 J
